## Hasman Aeroseal

Wedding Barn – Mickleton Hills Farm, Cotswolds

Low Class A ductwork systems

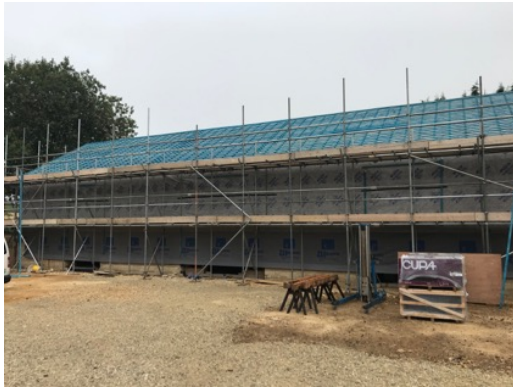
Mickleton Hills under construction

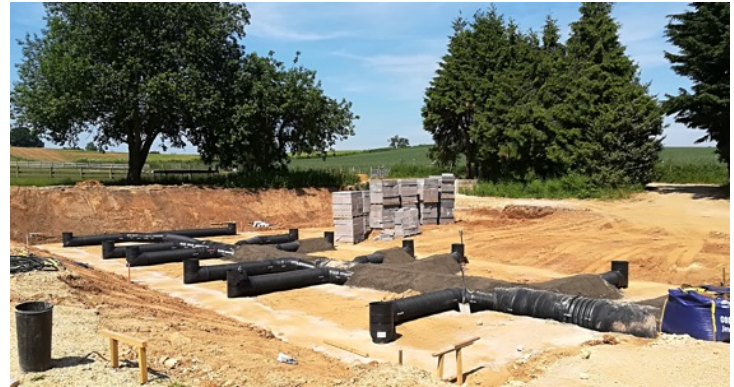
A new build wooden barn to be used as a wedding venue, the barn's design included an underground plastic ductwork system. The ductwork system leakage rates exceeded the allowable rate of 6% outlined in DW143. The ductwork leakage was not reachable as the plastic duct was underground, surrounded by the buildings concrete foundation.

Ductwork installed before concrete foundation laid

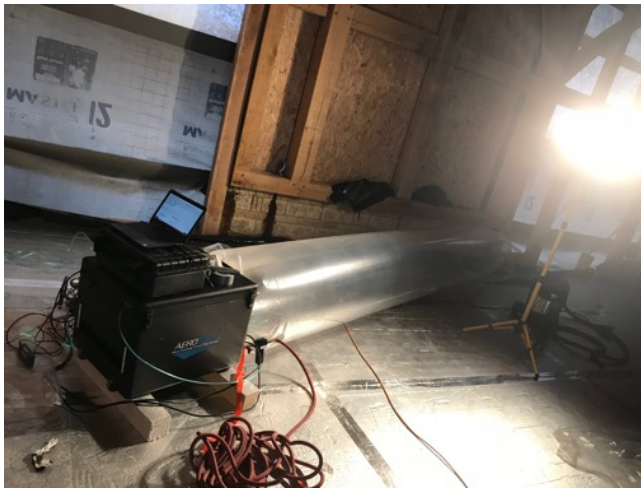
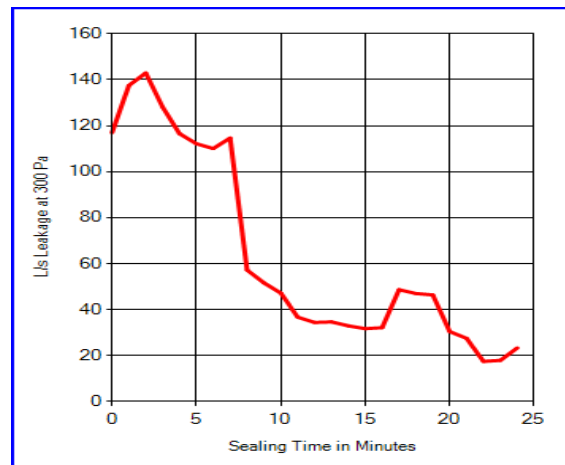
Duct surface area:	77.35m <sup>2</sup>
Pre-seal leakage:	117 l/s @300Pa (%)
Post-seal leakage:	23.15 l/s @300Pa (%)
Leakage reduction:	80.10%
Equivalent class:	Class C

After Aeroseal the buildings system leakage was reduced by an average of 80.1%. The system passed pressure testing with leakage rates equivalent of class C, above the building's specification of class A. Sealing could not be progressed any further, suggesting that one single leak was present on the system greater than 20mm in width, all other points of leakage were closed.

Aeroseal equipment in use and leakage reduction data
